Removal and installation of right A-pillar upper shield assembly

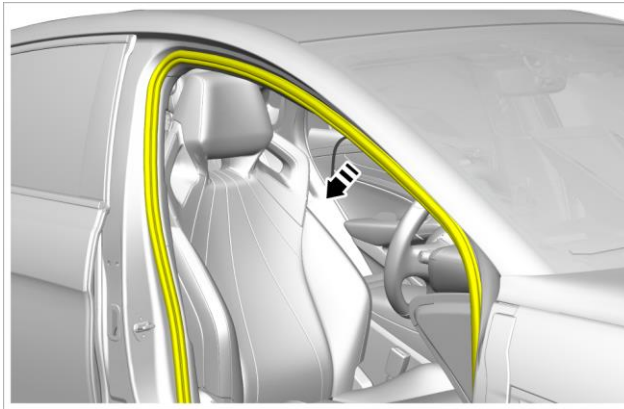
1. Power off the low-voltage electrical system. Refer to [Power-off and power-on of low-voltage electrical system](#)
2. Remove the side curtain airbag identification plug cap. Refer to [Removal and installation of side curtain airbag identification plug cap \(on A-pillar upper shield assembly\)](#)
3. Remove the front right door frame sealing strip partially.

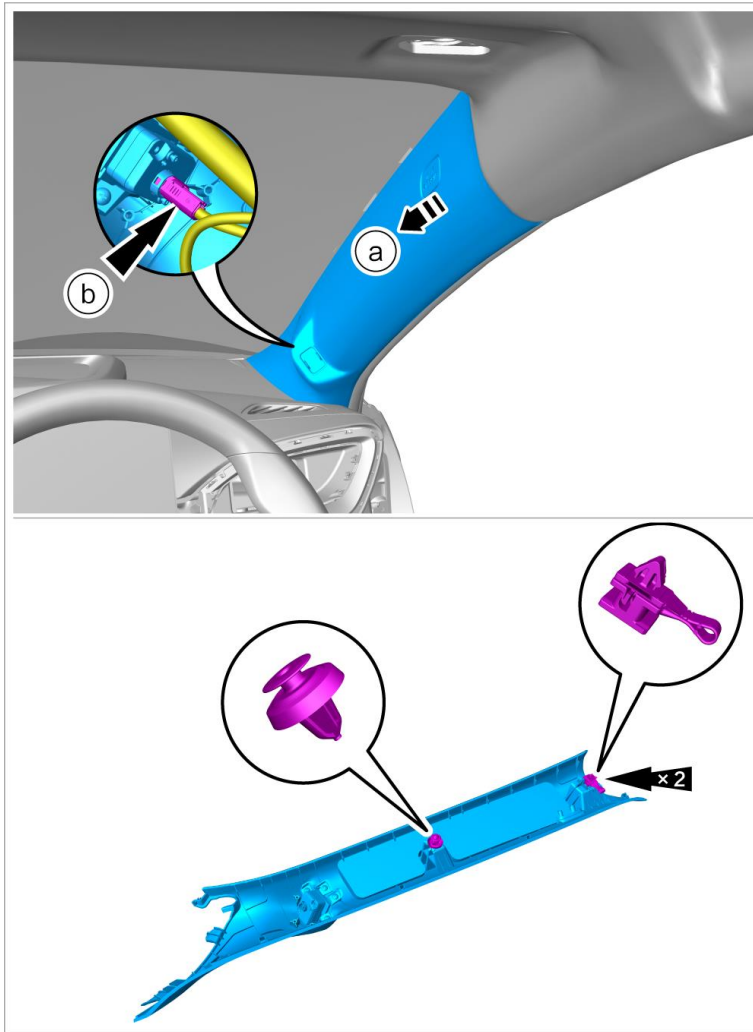
4. Remove the right A-pillar upper shield assembly.
 - a. Detach 2 fixing clips and move aside the right A-pillar upper shield assembly.
 - b. Disconnect 1 connector from the DMS infrared camera and take out the right A-pillar upper shield assembly.
